**Engineering and Organizational Issues Related to
the World Trade Center Terrorist Attack**

**Overview of Damage to Buildings
Near Ground Zero**

By Michel Bruneau, Andrew Whittaker and Andrei Reinhorn

March 2002

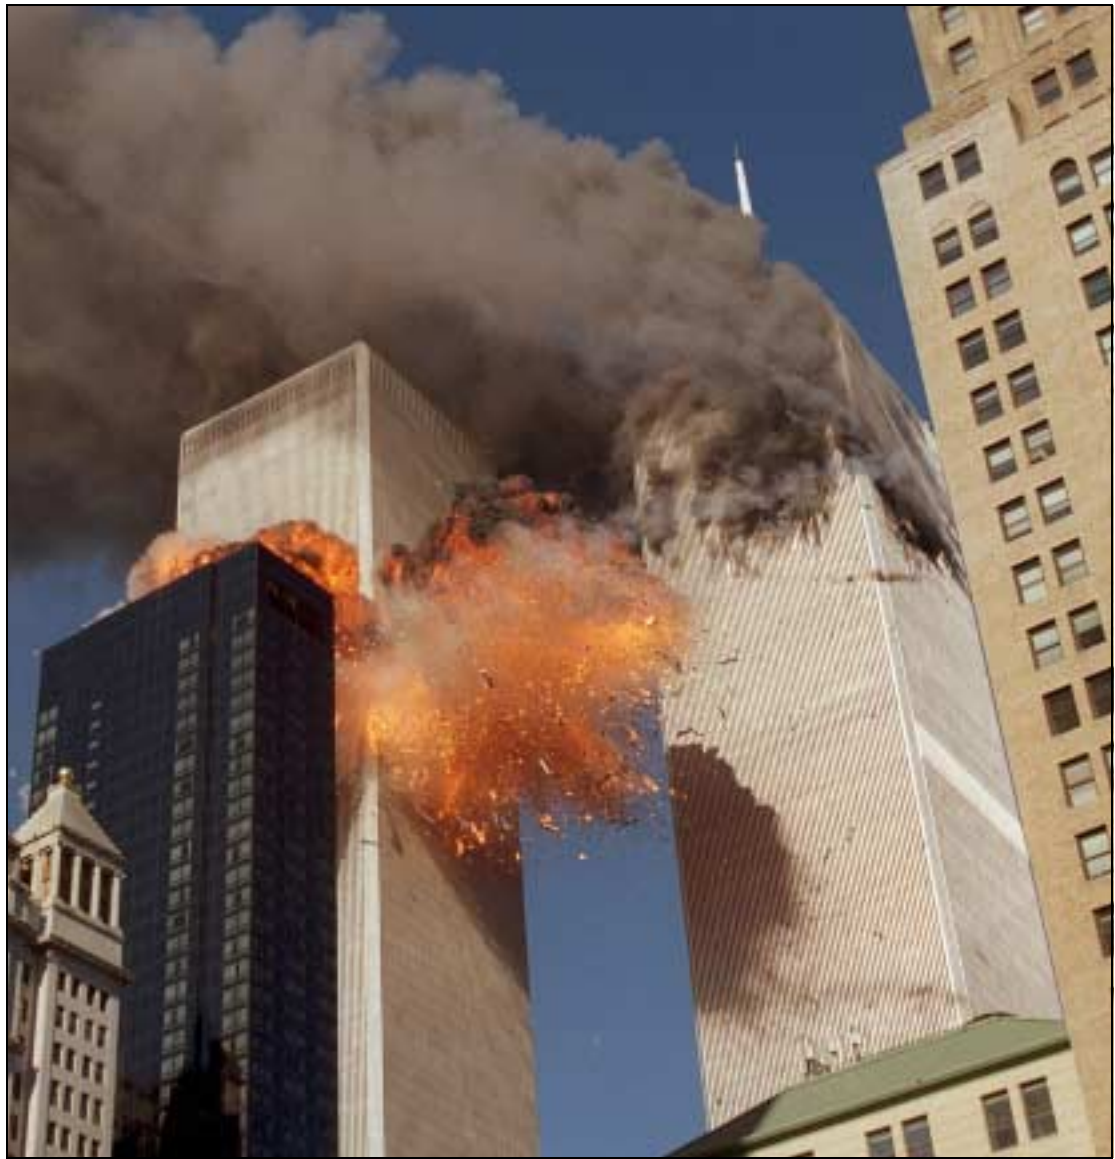
In both cases, jet fuel ignited at impact. Debris from the planes and the buildings were ejected into the adjacent space and buildings, principally in the directions of impact. Some of these debris were ablaze (see Figure 2.1). The fuel-fed fires raged at the stories where the collisions occurred, and propagated to the stories above. The extent of the spread and intensity of the fires are unknown.

Figure 2.1. Explosion following the plane impact into the South Tower

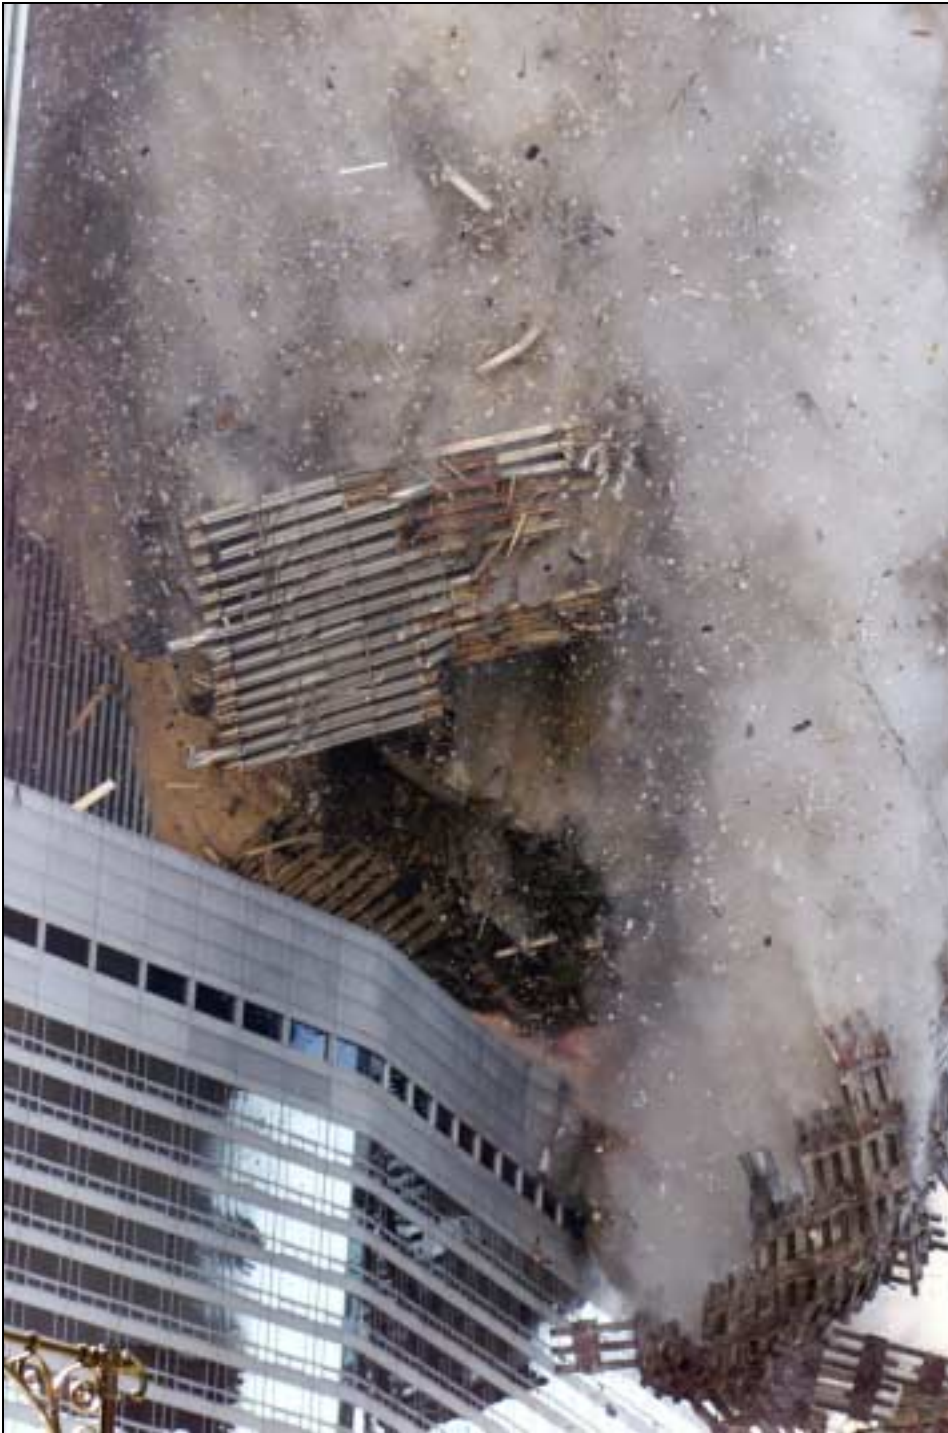
Figure 2.2. Large segments of the World Trade Center perimeter frame fell on adjacent buildings during the collapse of the towers

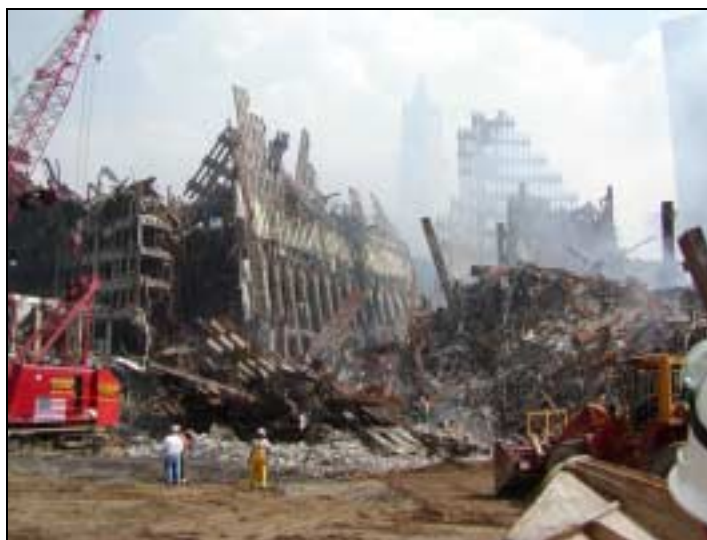
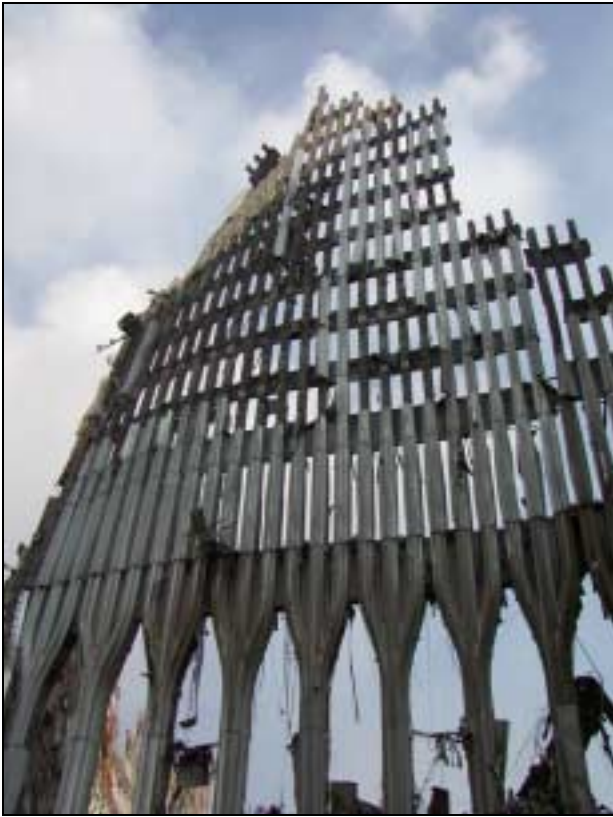
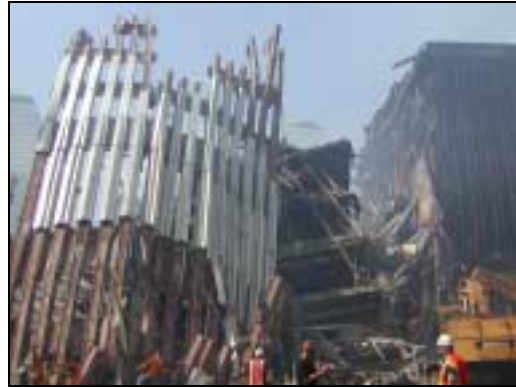
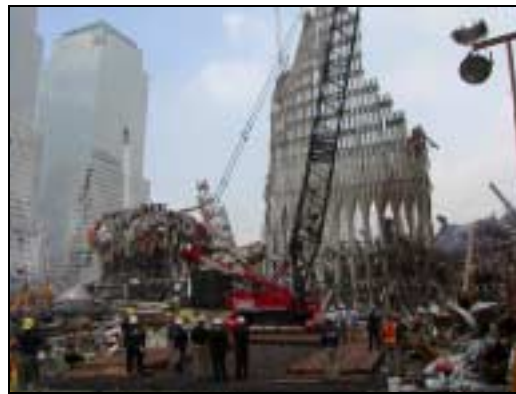
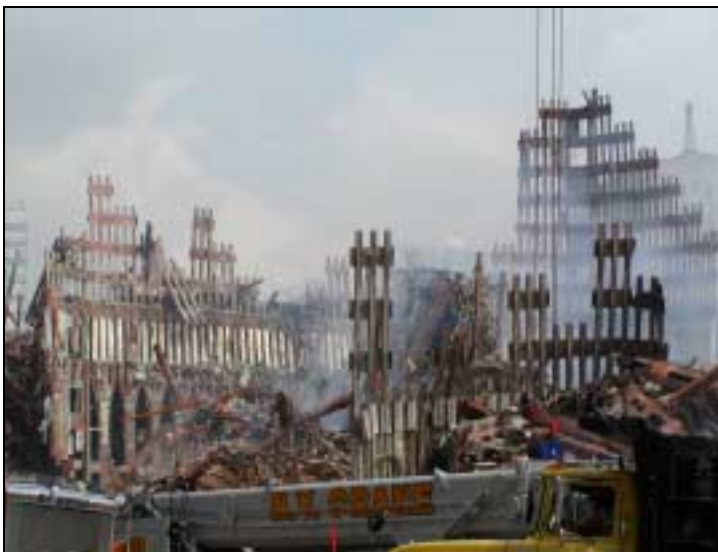
The only recognizable portions of WTC 1 and 2 on September 21, 2001, were parts of the exterior tube described above that remained standing in the debris pile (Figure 3.5). Some evidence of the building modular construction described in the previous paragraph could be observed from these parts of the building structural shell (Figure 3.6). The typical four-bolt column splices could be also observed (Figure 3.7), along with the hole on the side of each hollow rectangular column that provided access for erection of the frames (Figure 3.7, bottom photograph). As will be seen in the subsequent sections, some of these three-column modules became multi-ton projectiles that impacted and damaged adjacent buildings as the towers collapsed. The interior of the building shell (see Figure 3.6, top photographs) shows some evidence of where the supporting seats were located for the floor joists.

Figure 3.5. Portions of the perimeter tubes of WTC 1 and 2 remained standing in the debris pile (as of September 21, 2001)

*Figure 3.5. (continued).
Portions of the perimeter
tubes of WTC 1 and 2 that
remained standing in the
debris pile (as of September
21, 2001)*

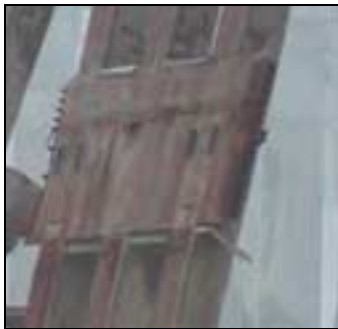
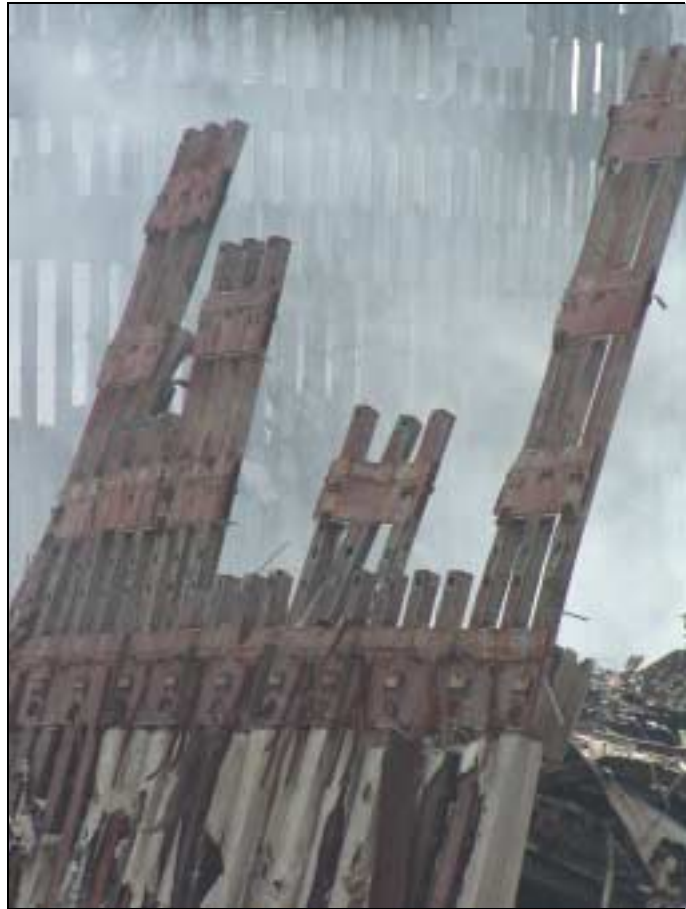
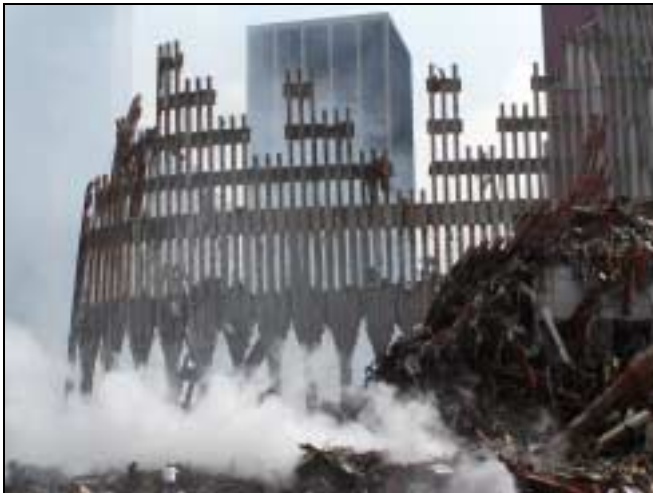
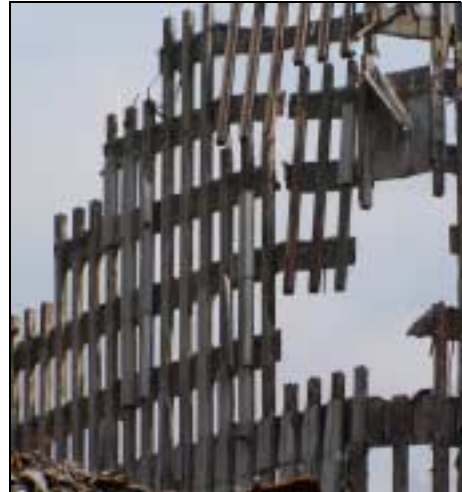
Figure 3.6. Modular construction of the towers

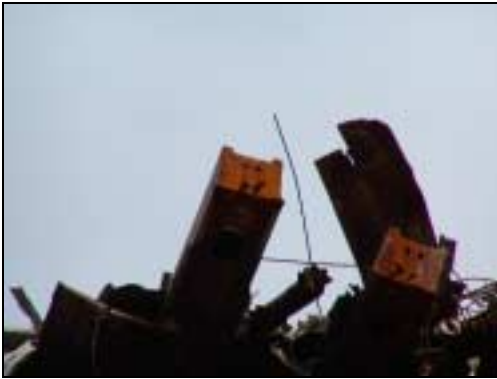
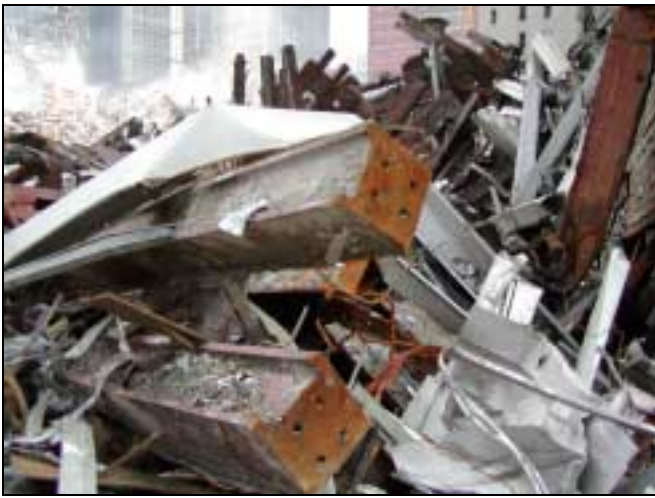
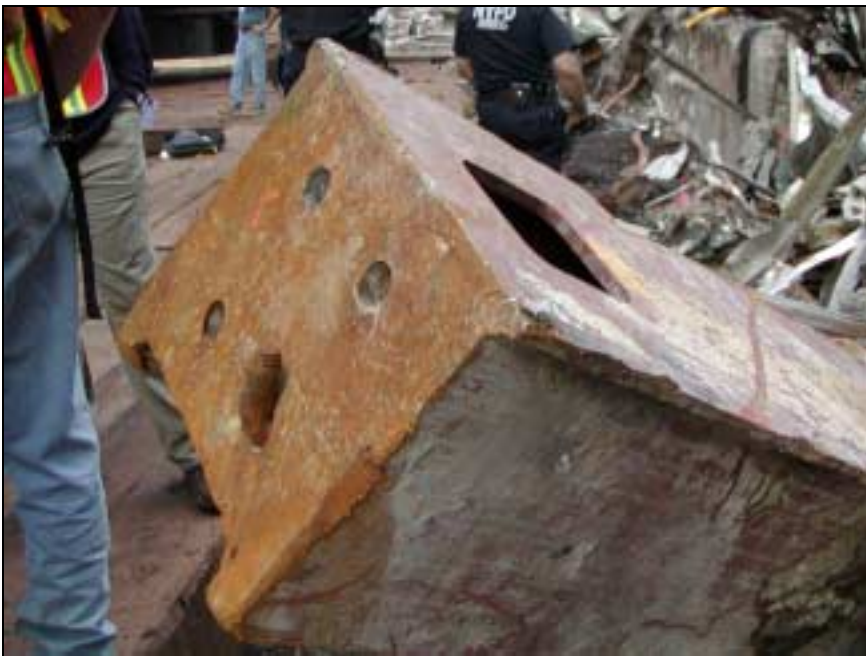
Figure 3.7. Typical four-bolt column splices and access holes on the side of hollow rectangular columns

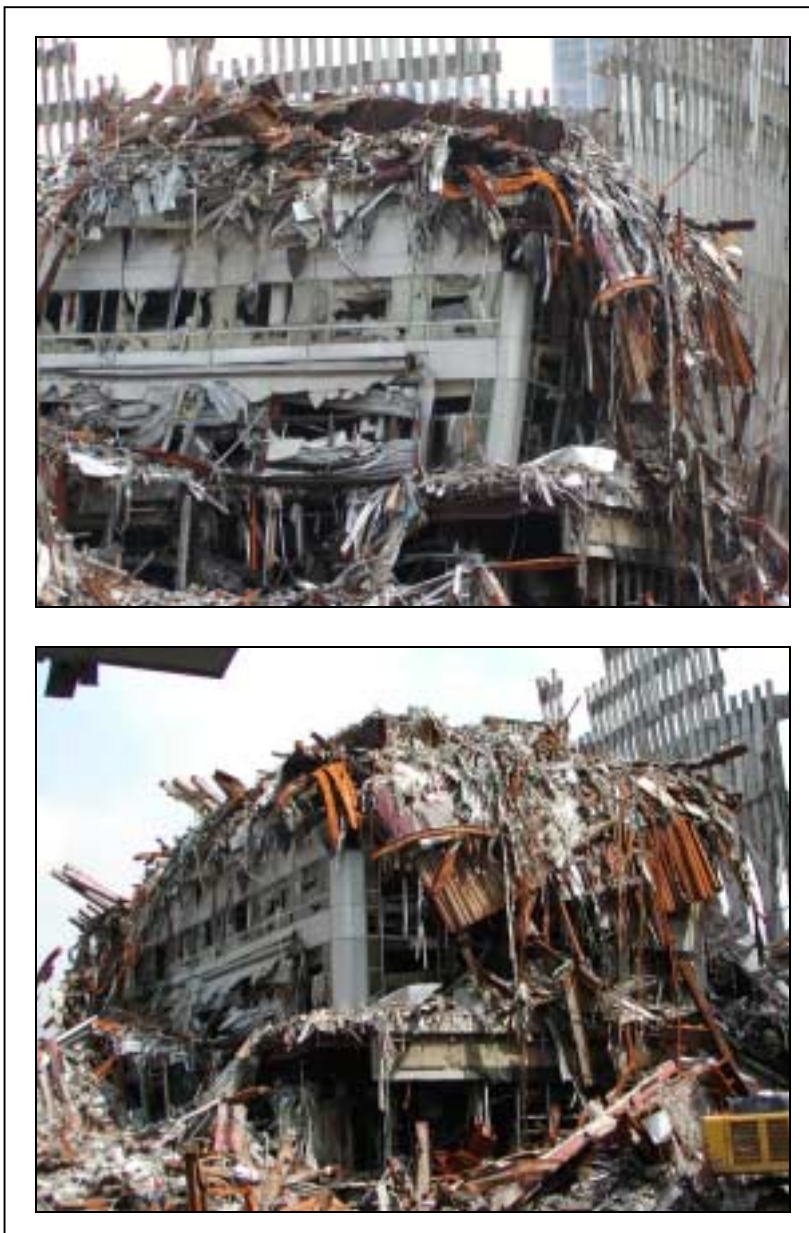
World Trade Center 3 (WTC 3) served as the Vista Hotel (formerly the Marriott hotel), and was located at the base of the two twin towers, immediately adjacent to and to the west of WTC 2 and to the south of WTC 1. It was effectively destroyed by falling debris from the collapse of the towers (see Figure 3.8). Although the building was a total loss, the fact that stories remain standing, albeit in a state of extreme damage, instead of being totally destroyed, could be partly due to the fact that the falling debris from the collapsing towers, for the most part, remained within their plan footprints.

*Figure 3.8.
Debris falling
destroyed WTC 3*

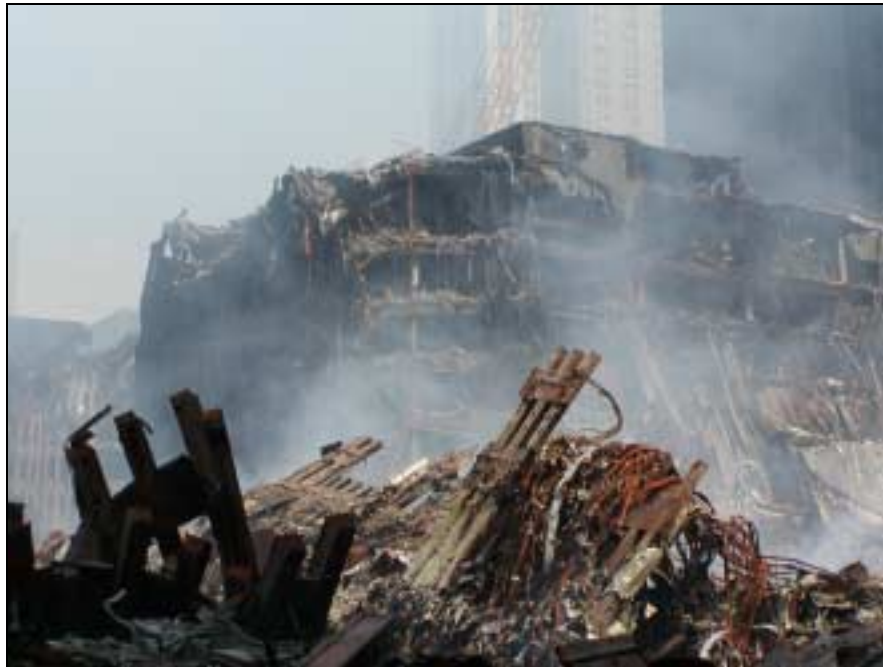
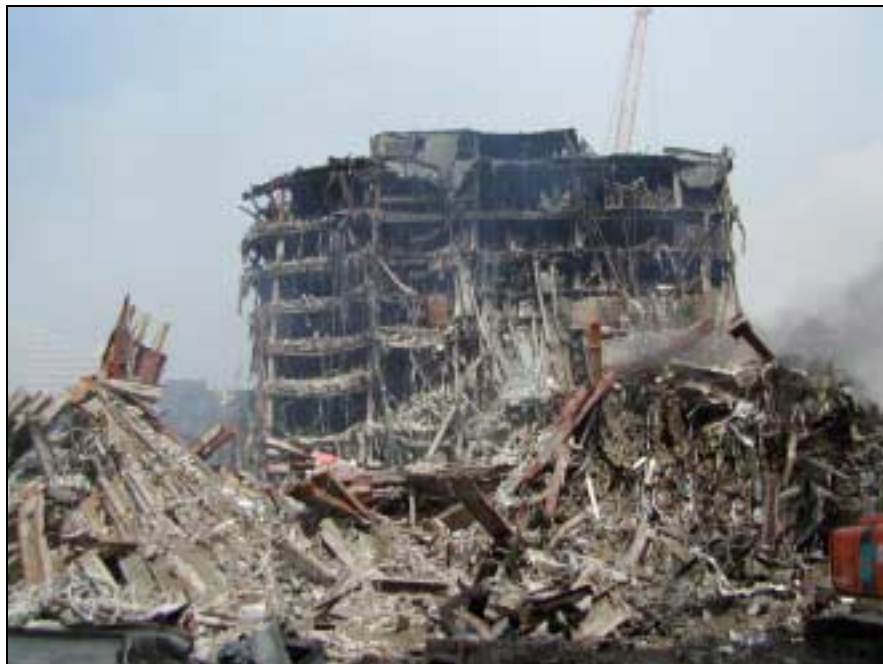
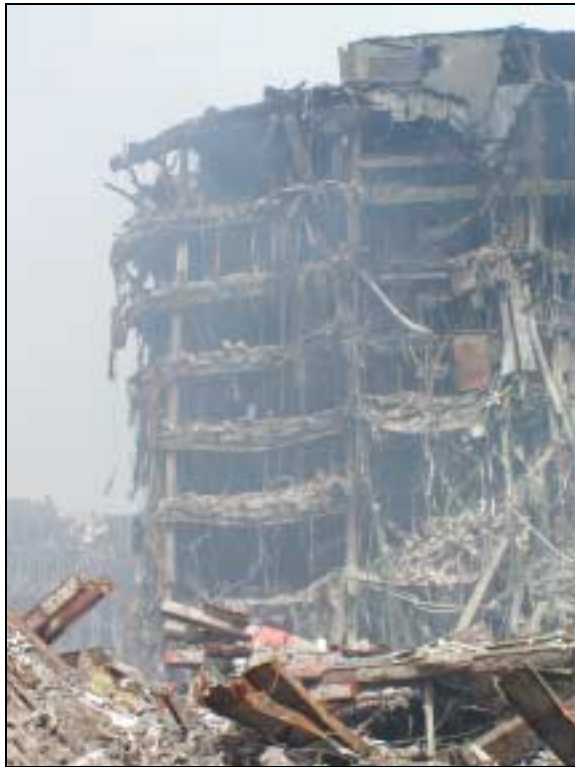
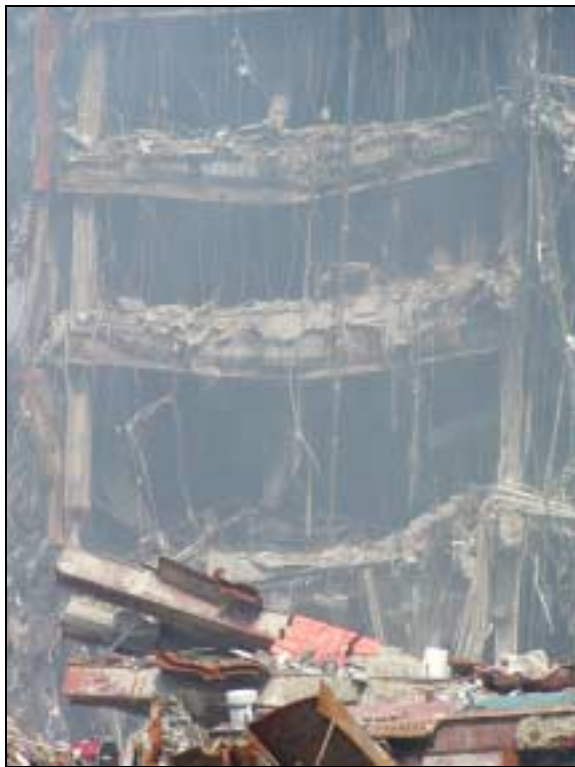
World Trade Center 4 (WTC 4) was similarly impacted by falling debris. The large permanent deformations (sagging) of many beams in that building (Figure 3.9) can be attributed to a combination of impact forces from falling debris and extensive fire damage.

*Figure 3.9.
Falling and
burning debris
destroyed
WTC 4*

*Figure 3.9. (continued).
Falling and burning debris
destroyed WTC 4*

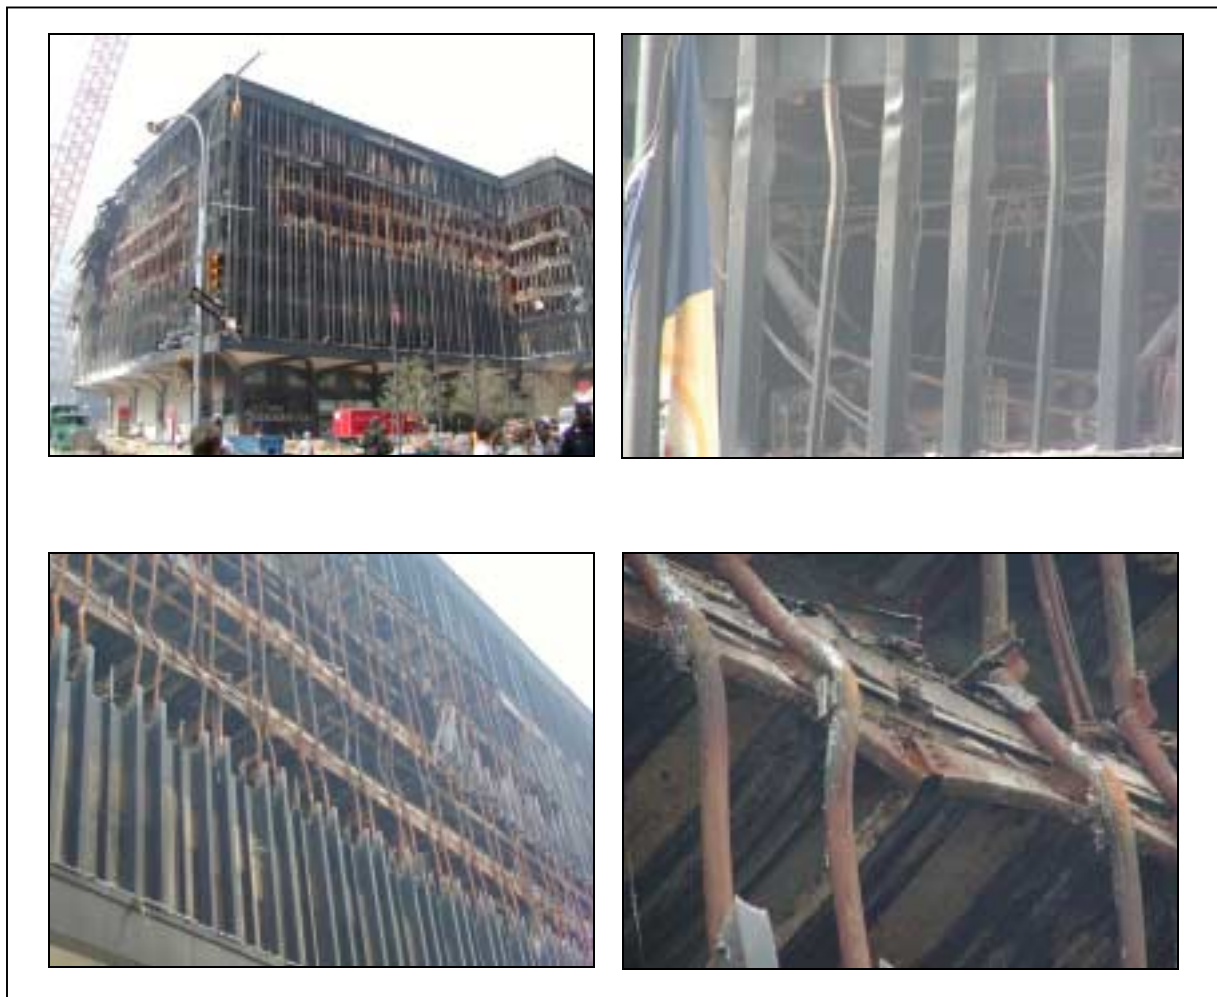
World Trade Center 5 (WTC 5) was located somewhat further from the towers than WTC 3 and 4, and was likely not showered by as much falling debris as these buildings were. However, parts of the building were still severely impacted. World Trade Center 6 (WTC 6) was immediately adjacent to WTC 1, and suffered tremendous damage. Both buildings were apparently hit by burning debris following the plane impact, and extensive fire-related damage was observed. Large heat distortion of structural members was observed in WTC 5 (Figure 3.10). Similar damage was also observed in WTC 6 (Figure 3.11).

Figure 3.10. Fire related damage to WTC 5

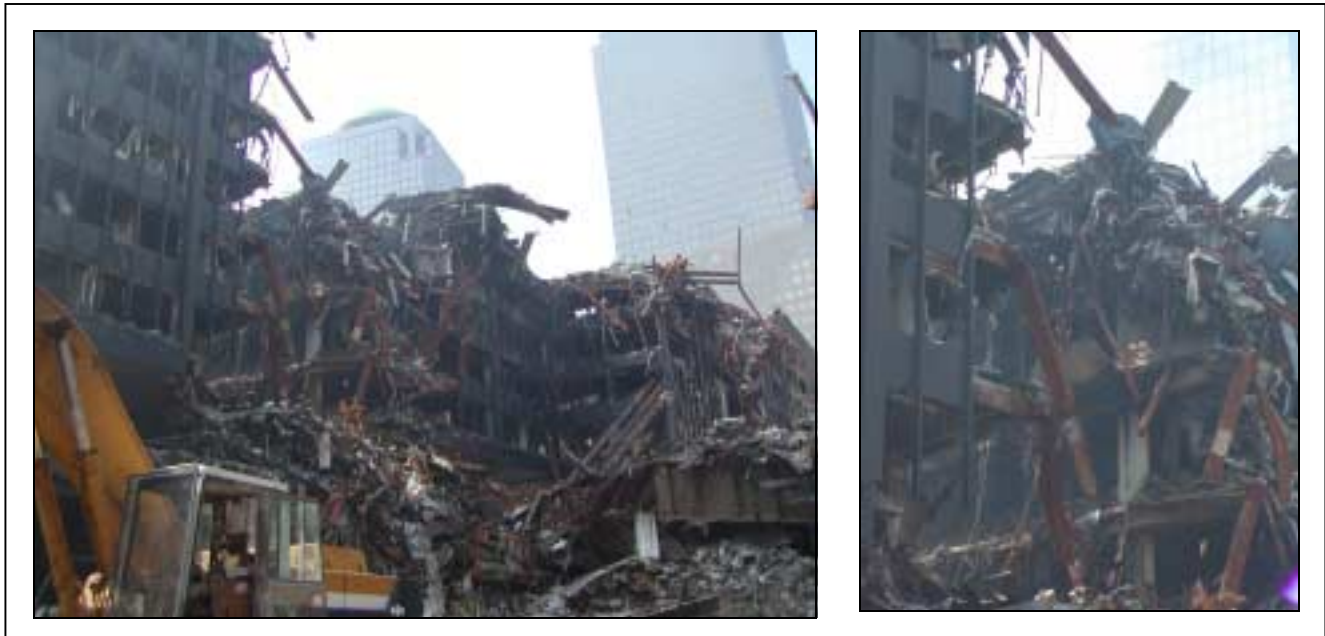
Figure 3.11. Impact and fire-related damage to WTC 6

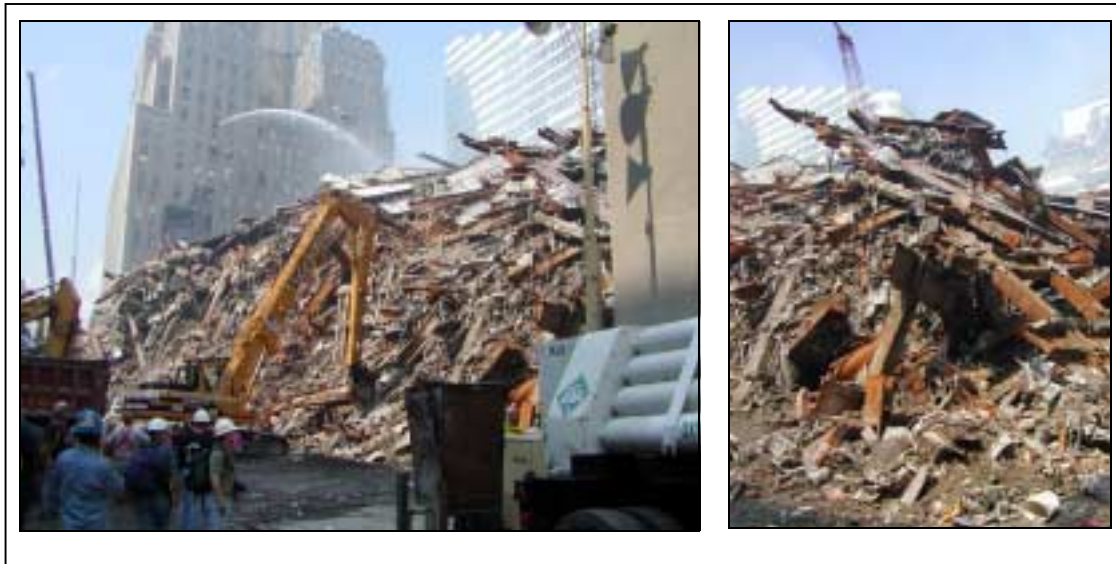
At 5:25 p.m. on September 11, 2001, WTC 7 collapsed as a consequence of damage and uncontrolled fire. The resulting debris pile was approximately seven stories high (Figure 3.12). Little reliable information on the collapse sequence can be surmised from the debris. Portions of conventional steel moment-resisting frames were observed in the debris pile (Figure 3.13), as well as distorted segments of beam stubs welded to columns with bolted splices a few feet away from the columns (Figure 3.14).

Figure 3.12. WTC 7 collapsed as a consequence of damage and uncontrolled fire

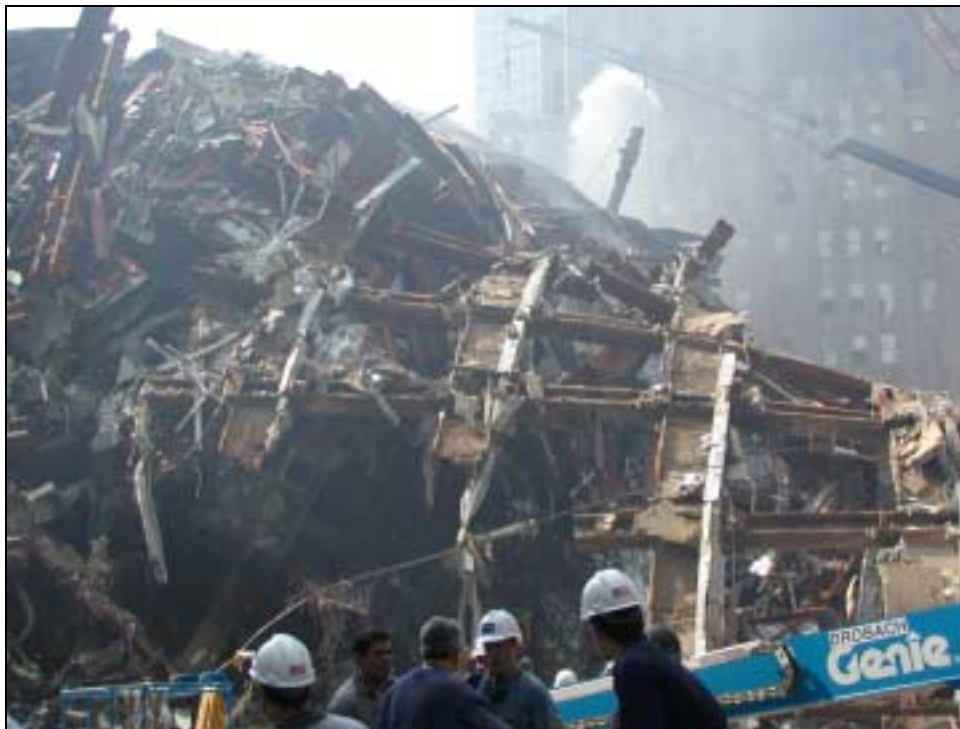
Figure 3.13. Portions of conventional steel moment-resisting frames were observed in the debris pile

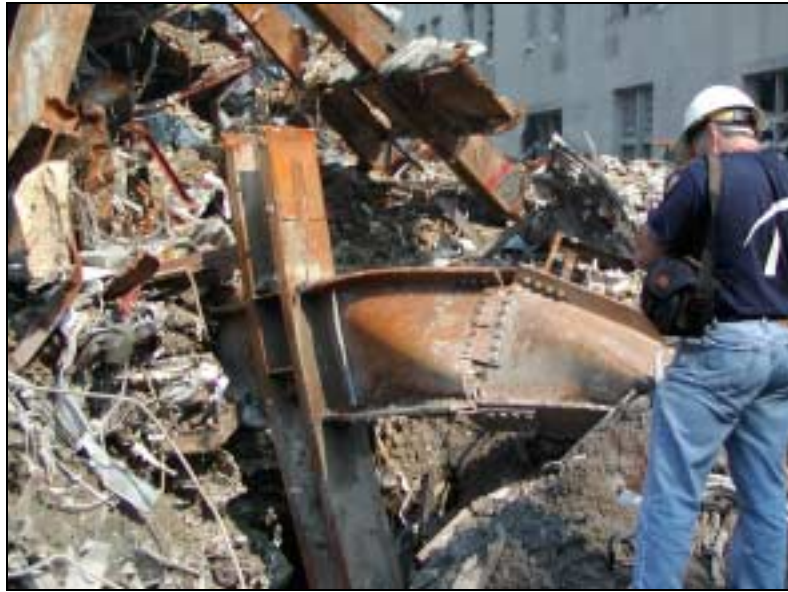
Figure 3.14 Distorted segments of beam stubs welded to the columns

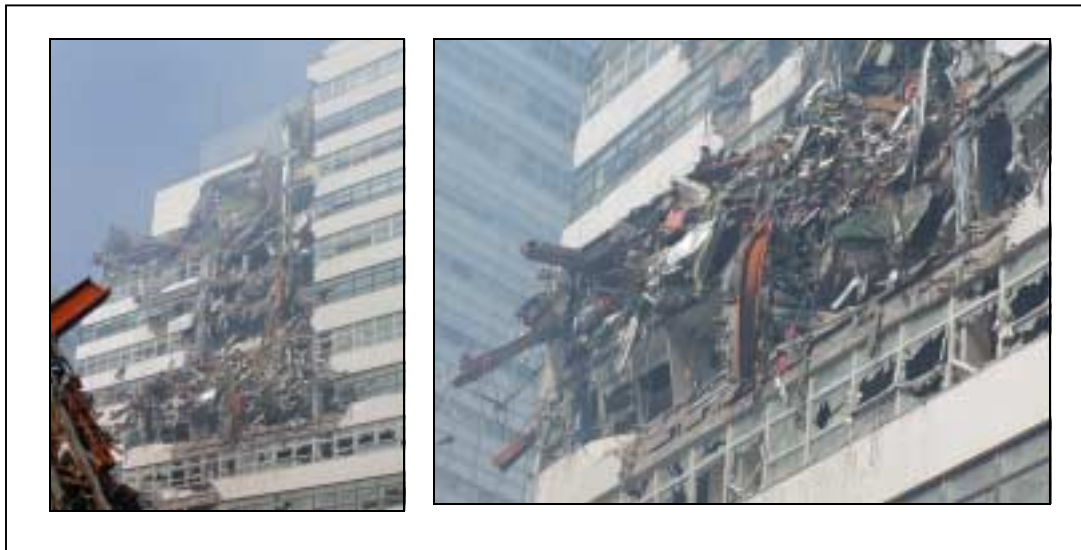
As WTC 7 collapsed, it fell partly on an adjacent building at 30 West Broadway, causing significant damage (Figure 3.15, south face and Figure 3.16, west face). Beams were permanently distorted by the impact (Figure 3.17).

Figure 3.15. Damage to the south face of a building at 30 West Broadway due to impact from the collapse of WTC 7

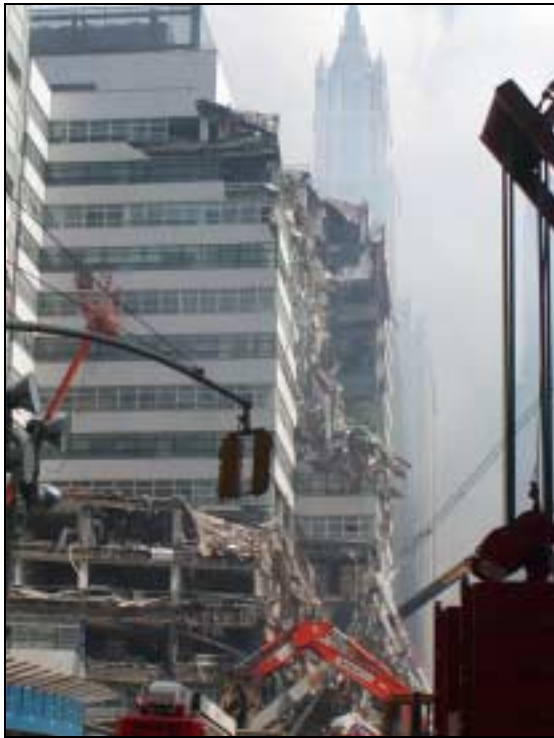
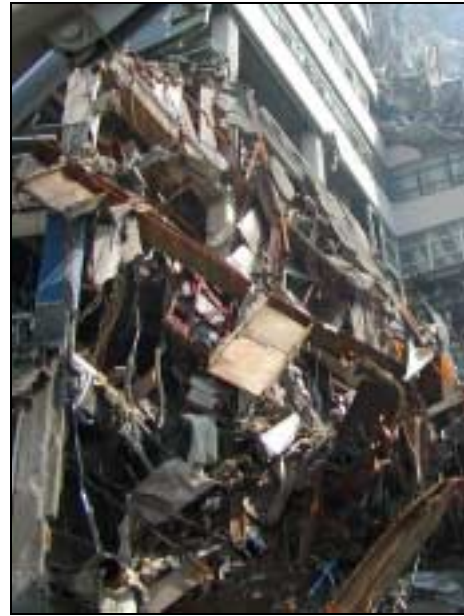
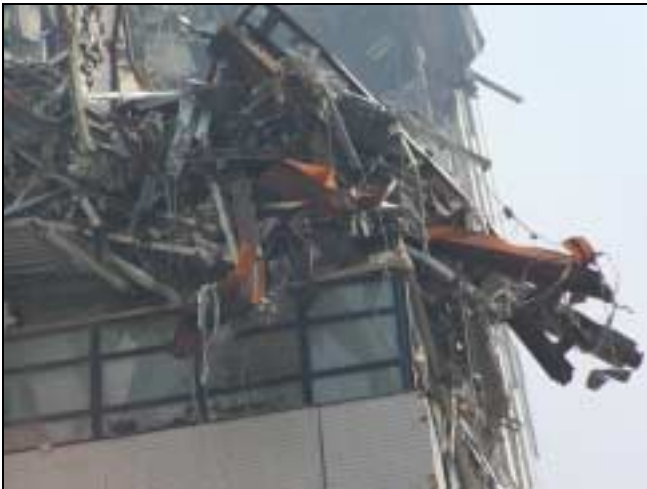
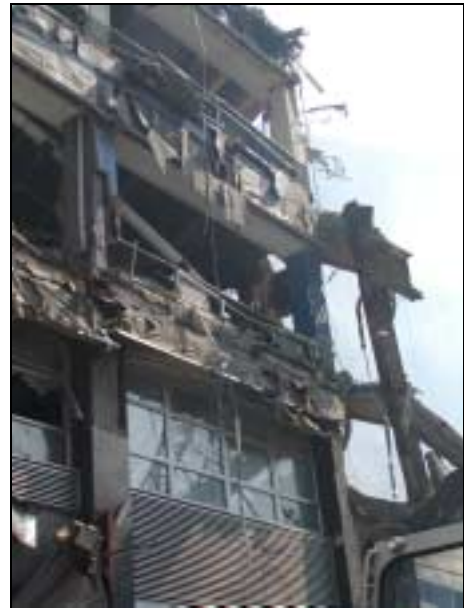
Figure 3.16 Damage to the west face of a building at 30 West Broadway due to impact from the collapse of WTC 7

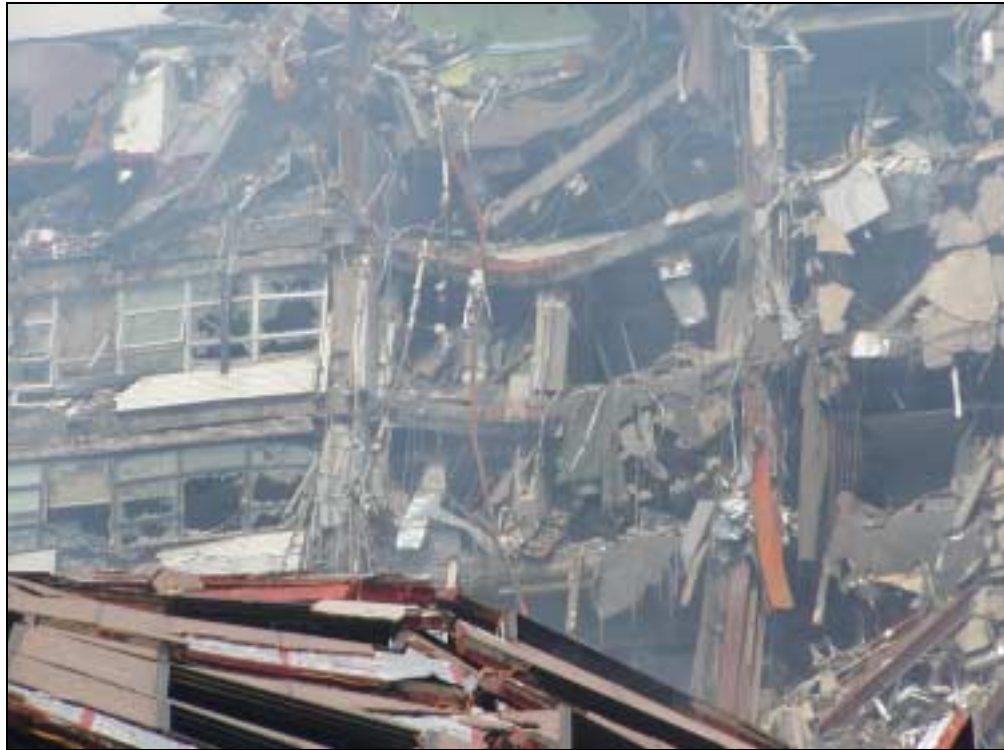
Figure 3.17. Beams in the building at 30 West Broadway were permanently distorted by the impact of falling debris

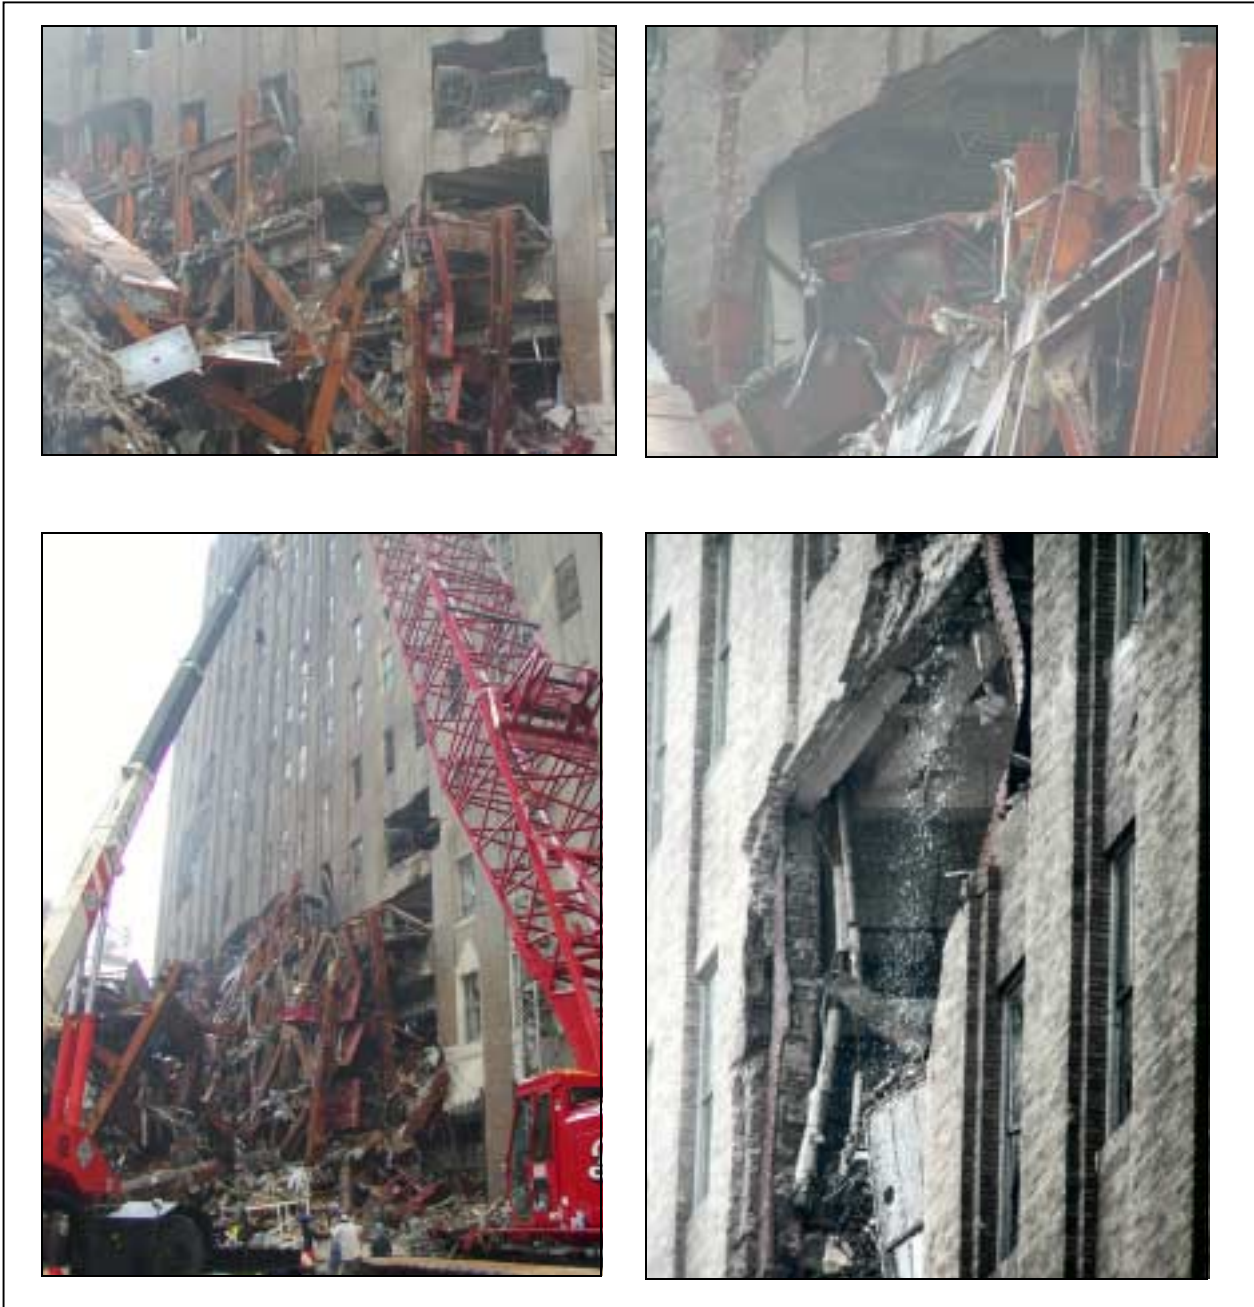
The collapse of World Trade Center 7 damaged the adjacent Verizon building. Damage to the west façade of that building is shown in Figure 3.18. Large segments of the WTC 7 braced framing were lodged against the Verizon building, which also suffered notable perforations in its framing and cladding. In particular, a steel column was severely distorted, presumably by debris impact (Figure 3.18, bottom right photo).

Figure 3.18. Damage to the west façade of the Verizon Building

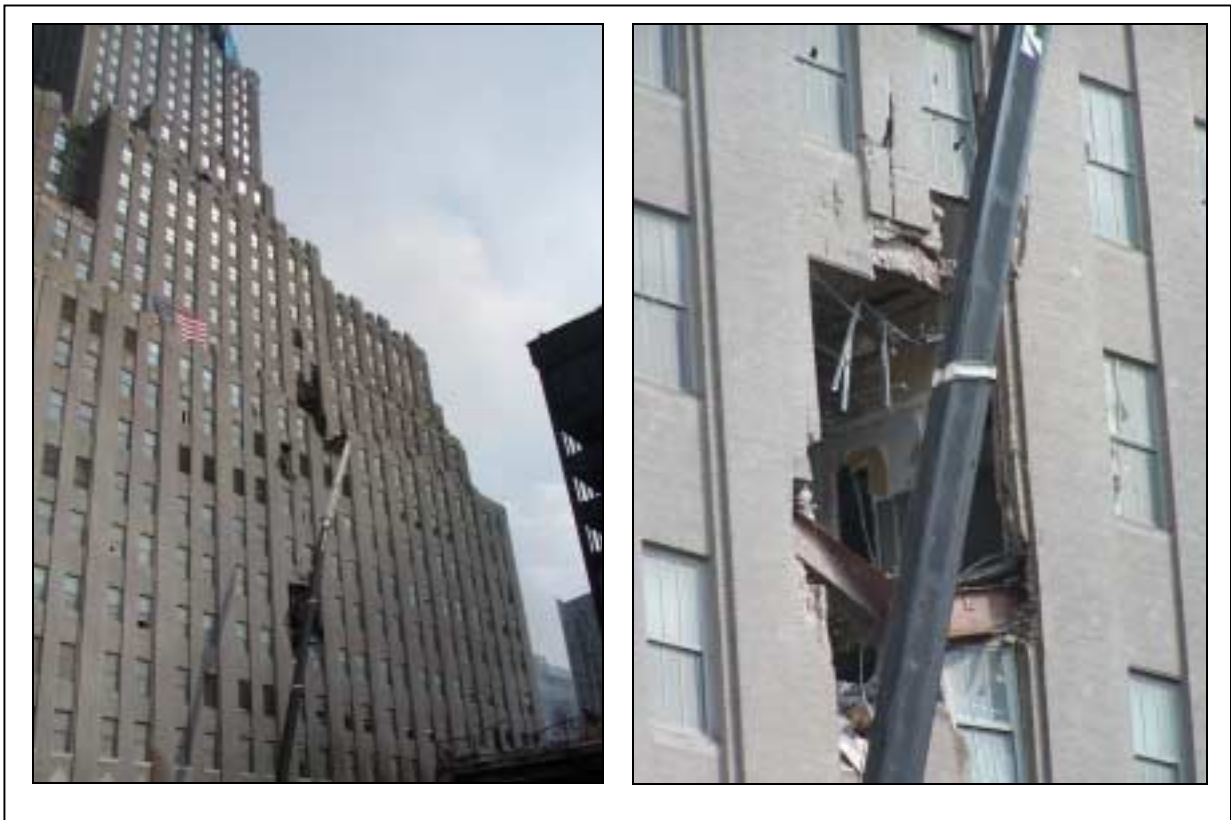
Limited relatively minor damage was also observed to the south façade, possibly produced by debris from the collapse of WTC 1 (Figure 3.19).

Figure 3.19. Minor damage to south façade of the Verizon building
